METAL / NONMETAL

Serious Injury Accident

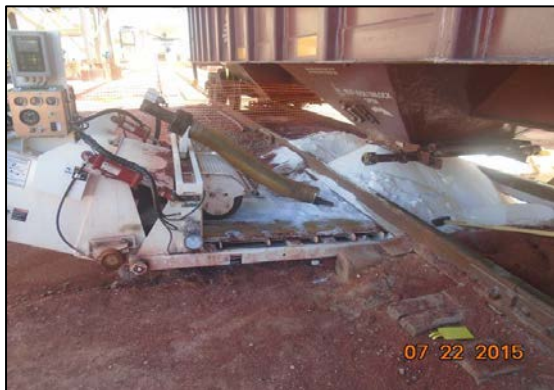
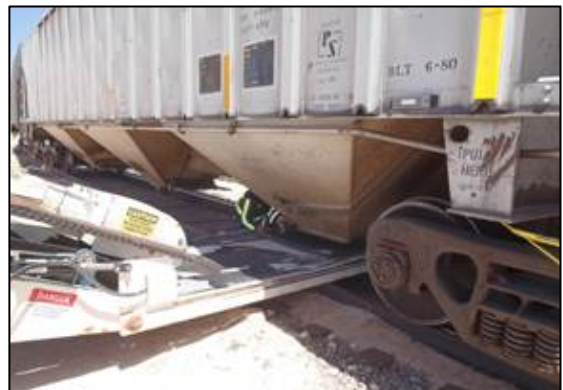
Potash Facility – A miner was entangled in the belt system while unloading a rail car into a belly dump haul truck using a portable conveyor system. The miner was released from the hospital without any apparent broken bones or lacerations. A similar accident occurred at a sand and gravel mine in 2014, however that accident resulted in a fatality.

- Ensure that persons are trained, including task training, to understand the hazards associated with the work being performed.
- Establish and discuss safe work procedures before beginning work. Identify and control all hazards associated with the work to be performed and use methods to properly protect persons.

- Conduct work place examinations before beginning any work.
- Position mobile conveyors to eliminate exposure of moving parts before operating.
- Identify hazards around conveyor systems, design guards, and or emergency stop systems before putting into operation.

- Always provide and maintain guarding sufficient to prevent contact with moving machine parts.
- Do not wear loose fitting clothing when working near moving machine parts.

- Do not place yourself in a position that will expose you to hazards while performing a task.
- Provide and maintain a safe means of access to all working places.
